# Manhole Inspection Summary

Manhole # S59K\_\_017MH

Insp Date: **7/23/08 2:25 PM**

**Location** Address: **rear 646 s macon st**

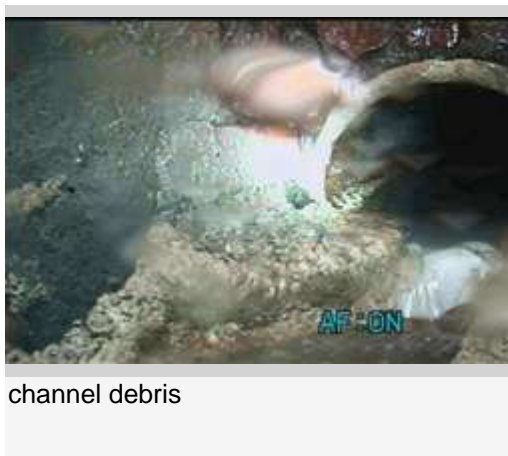
Defect 4

Condition: ☐ Sound ☐ Cracked ☐ Root Intrusion ☐ Deteriorated ☐ Leaks ☒ **Debris**

channel debris

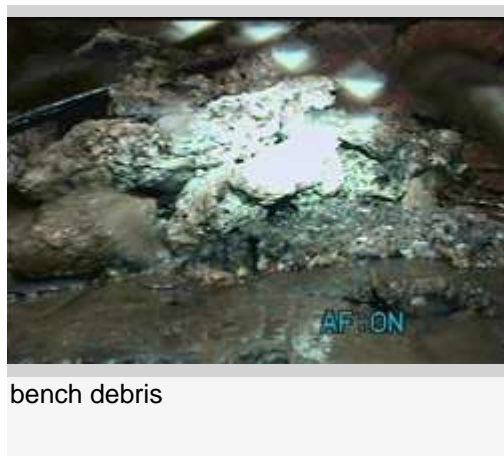
Defect 3

Condition: ☐ Sound ☐ Cracked ☐ Root Intrusion ☐ Deteriorated ☐ Leaks ☒ **Debris**

bench debris

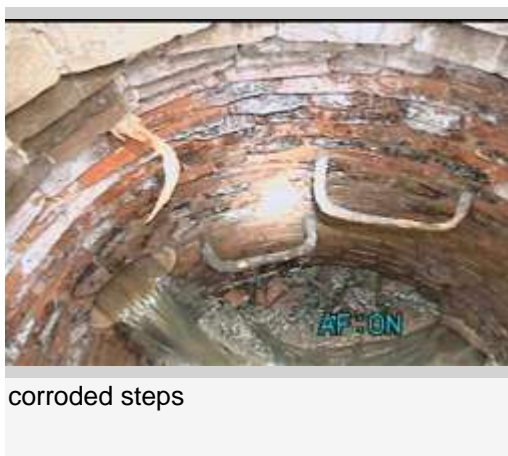
Defect 2

Count: **3** Missing: **1** ☒ **Corroded**

corroded steps

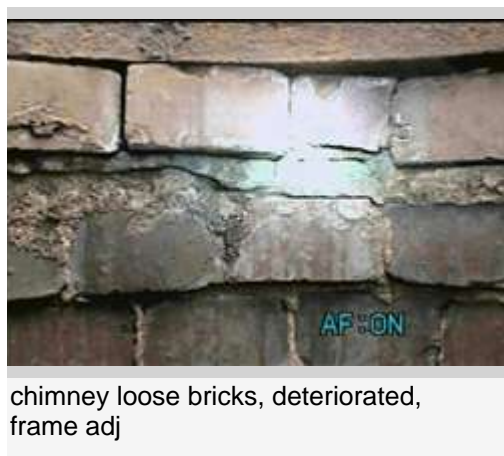
Defect 1

Condition: ☐ Sound ☐ Cracked ☐ Root Intrusion ☒ **Loose Brick** ☒ **Deteriorated**

chimney loose bricks, deteriorated,  
frame adj

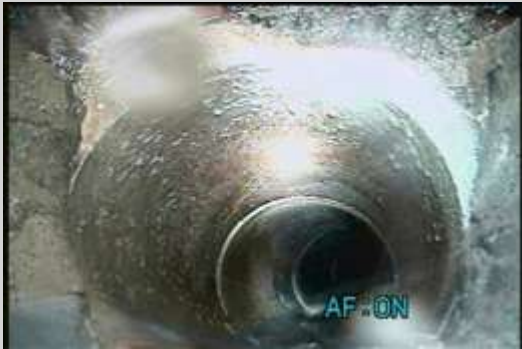
12 O'Clock Outflow

12 in. Circular Gravity Sewer  
Pipe Out @ 12 O'Clock

Pipe Material: **Clay** ☐ Pipe Lined

Invert Depth: 7.33 (ft.) Flow Characteristics: **Fast**

Deposits: ☒ None ☐ Mud ☐ Sludge ☐ Debris ☐ Grease

Infiltration: **None** Pipe Seal Cond: **Unknown**

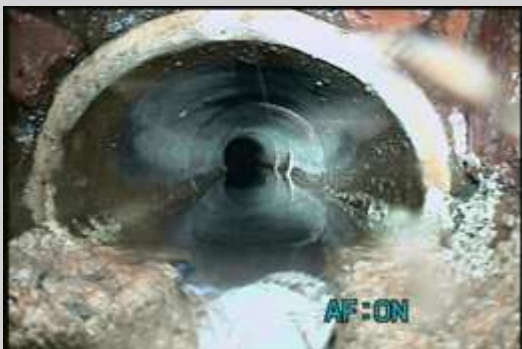
6 O'Clock Inflow

12 in. Circular Gravity Sewer  
Pipe In @ 6 O'Clock

Pipe Material: **Clay** ☐ Pipe Lined

Invert Depth: 7.16 (ft.) Flow Characteristics: **Fast**

Deposits: ☒ None ☐ Mud ☐ Sludge ☐ Debris ☐ Grease

Infiltration: **None** Pipe Seal Cond: **Unknown**

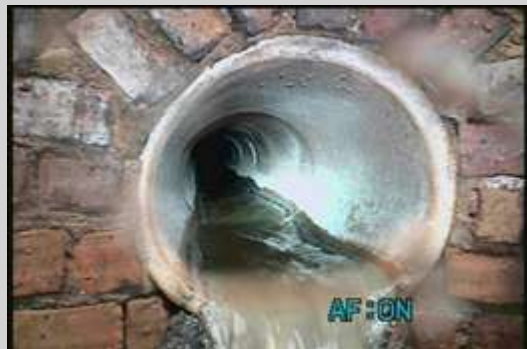
9 O'Clock Inflow

8 in. Circular Gravity Sewer  
Pipe In @ 9 O'Clock

no drop there is nothing below it

Pipe Material: **Clay** ☐ Pipe Lined

Invert Depth: **5.58** (ft.) Flow Characteristics: **Fast**

Infiltration: **None** Pipe Seal Cond: **Unknown**
